Manhole Inspection Summary

Manhole # S47EE_039MH

Insp Date: **7/17/08 10:39 AM**

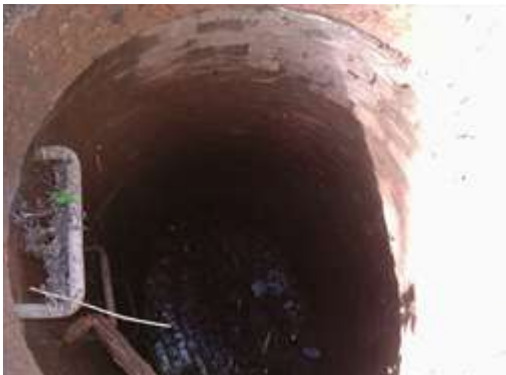
Defect 1

infiltration

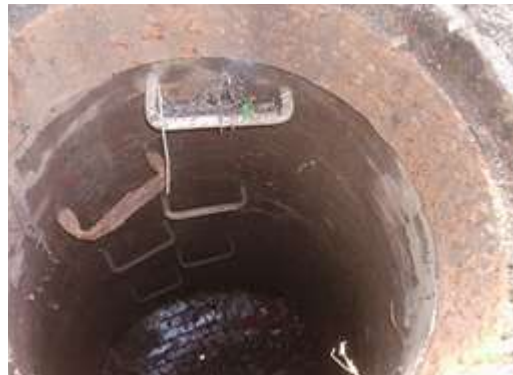
Defect 2

frame leaks

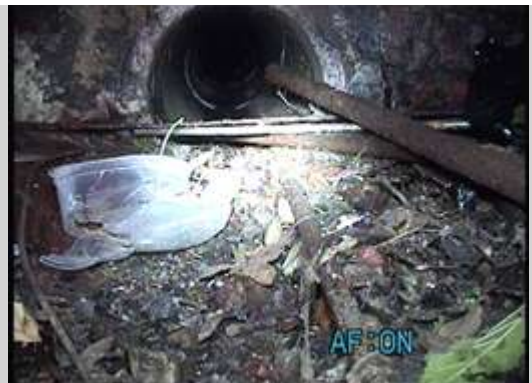
12 O'Clock Outflow

8 in. Circular Gravity Sewer
Pipe Out @ 12 O'Clock

Infiltration: **None** Pipe Seal Cond: **Sound**
